MEMORANDUM

Re: Willamette Cove Upland Facility
DU-6 Interim Action
Portland, Oregon
ECSI No. 2066
1056-05

This memorandum presents the proposed interim action at Decision Unit 6 (DU-6) for the Willamette Cove Upland Facility (the Facility; Figures 1 and 2) in the St. Johns area of Portland, Oregon. Work at the Facility is being conducted under Voluntary Agreement EC-NWR-00-26 between the Port of Portland (Port), Metro, and the Oregon Department of Environmental Quality (DEQ).

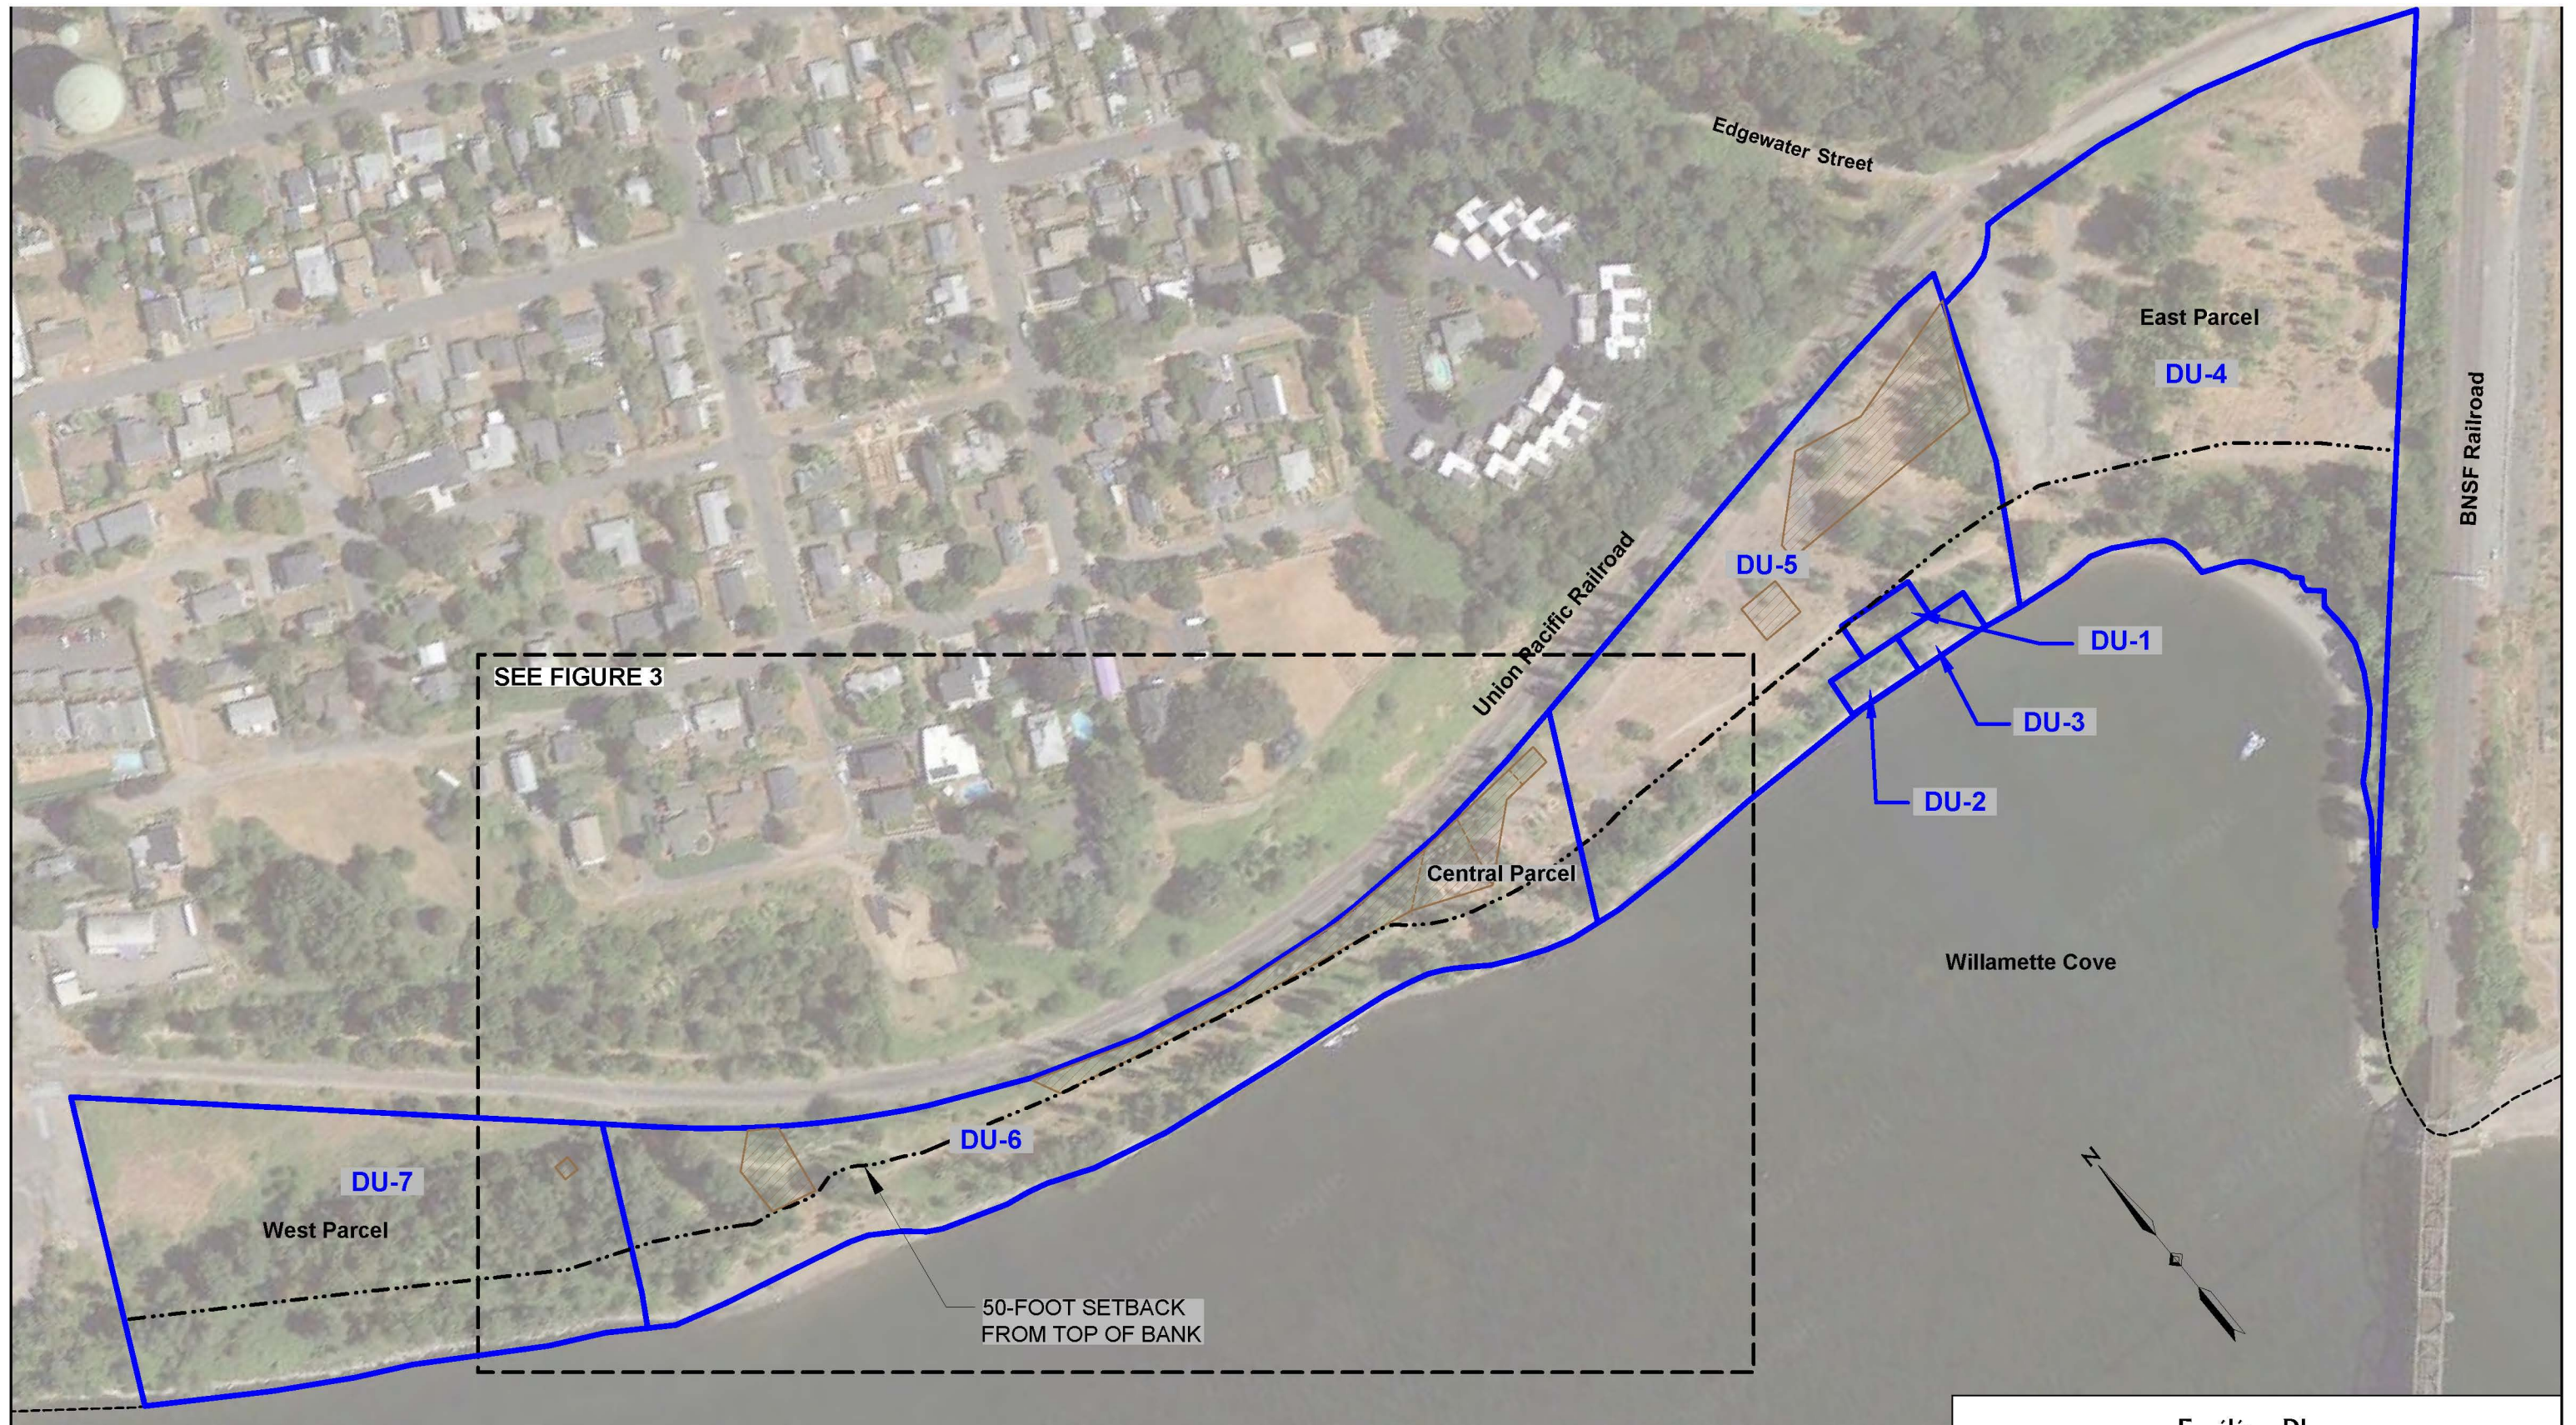
Figure
2

Facility Plan

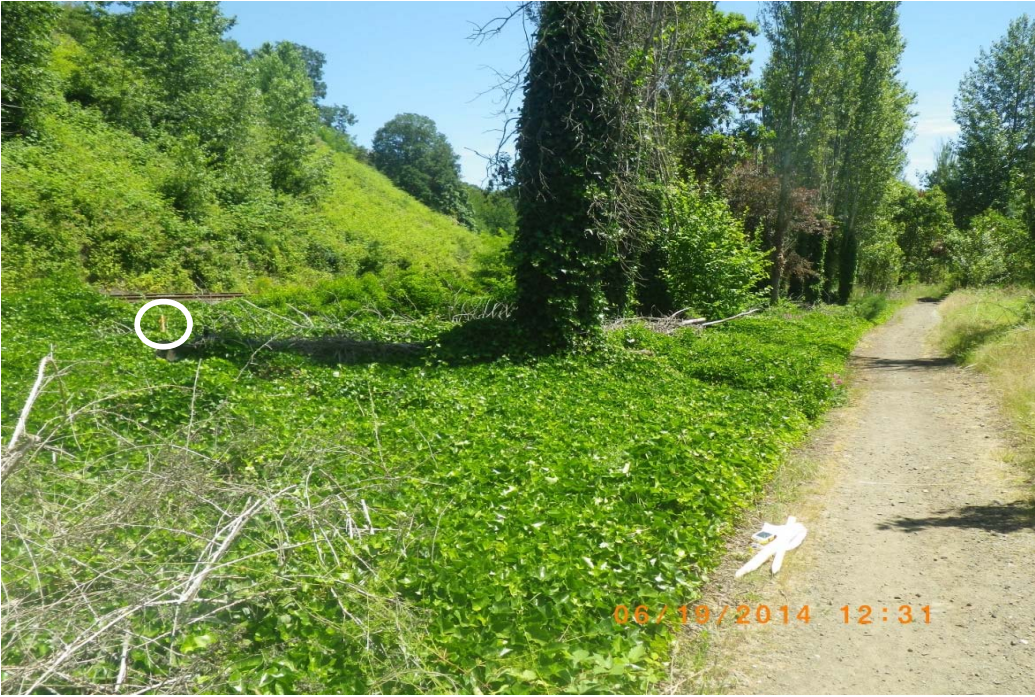
Photo No: 1

Photo Date: 6/19/2014	
Orientation: East	
Description: Stake at location DU-6-COMP-5-3 (shown in white circle).	
Photo No: 2

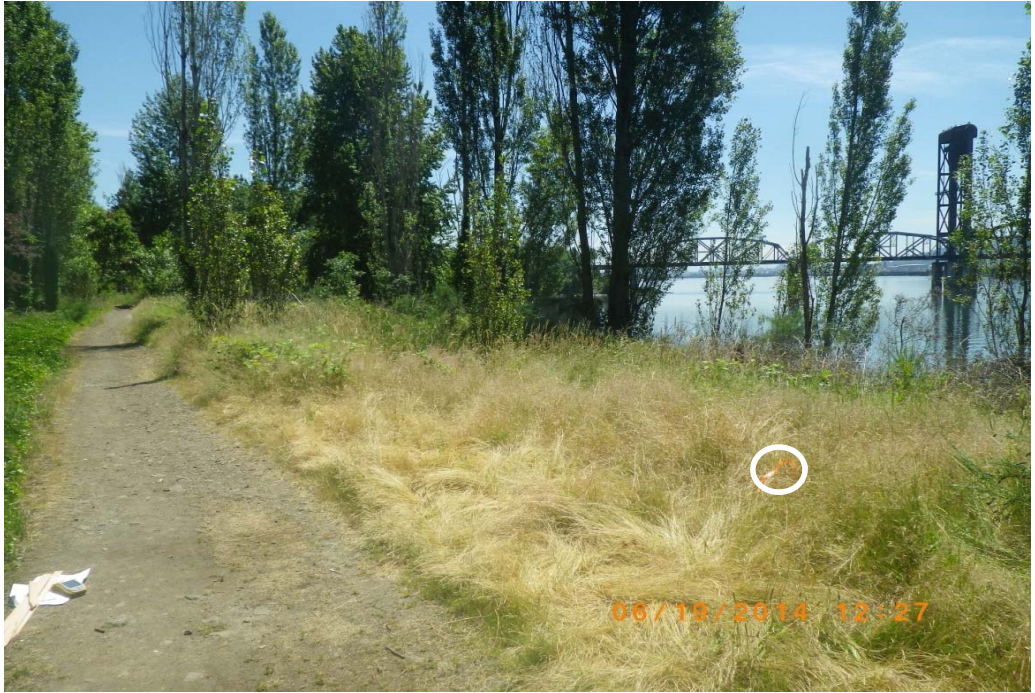
Photo Date: 6/19/2014	
Orientation: Southeast	
Description: Stake at location DU-6-COMP-5-4 (shown in white circle).

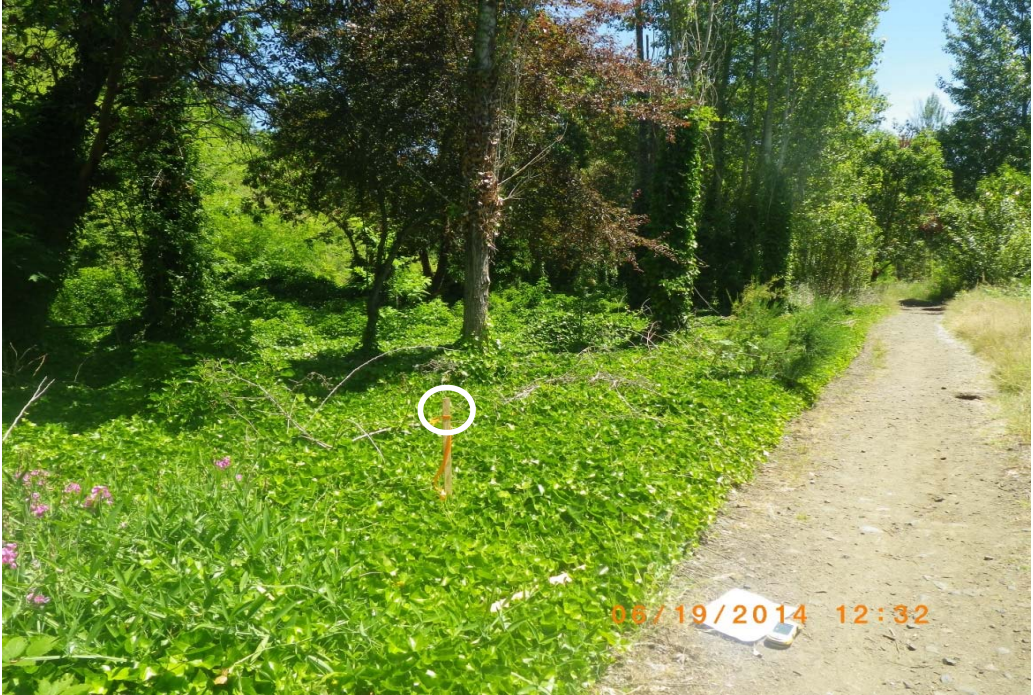
Photo No: 3

Photo Date: 6/19/2014	
Orientation: East	
Description: Stake at location DU-6-COMP-5-6 (shown in white circle).	
Photo No: 4

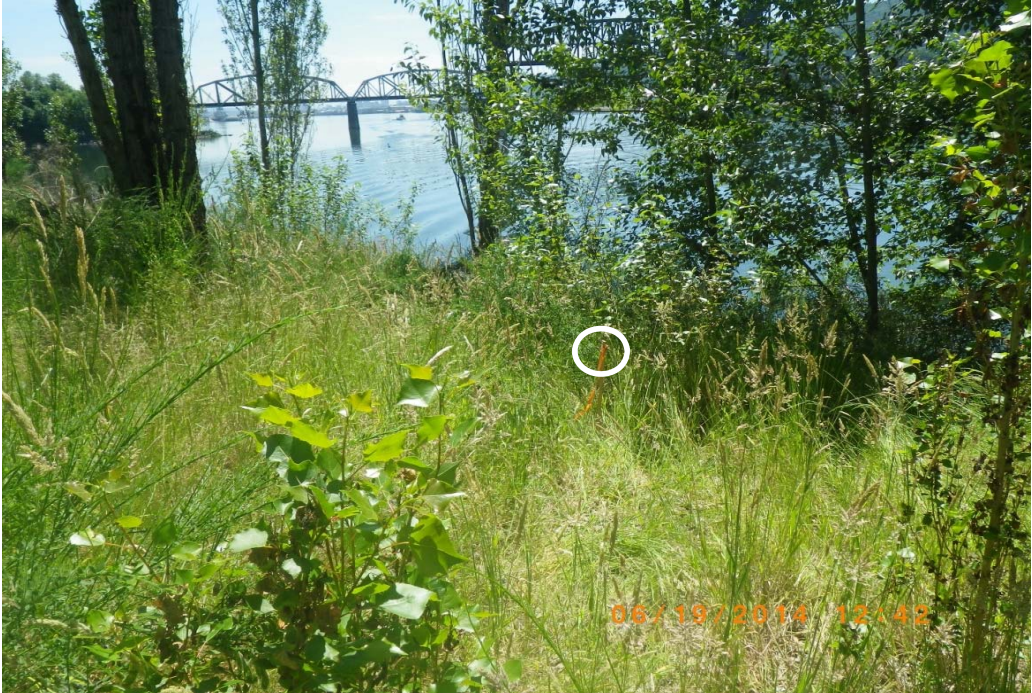
Photo Date: 6/19/2014	
Orientation: Southeast	
Description: Stake at location DU-6-COMP-6-4 (shown in white circle).

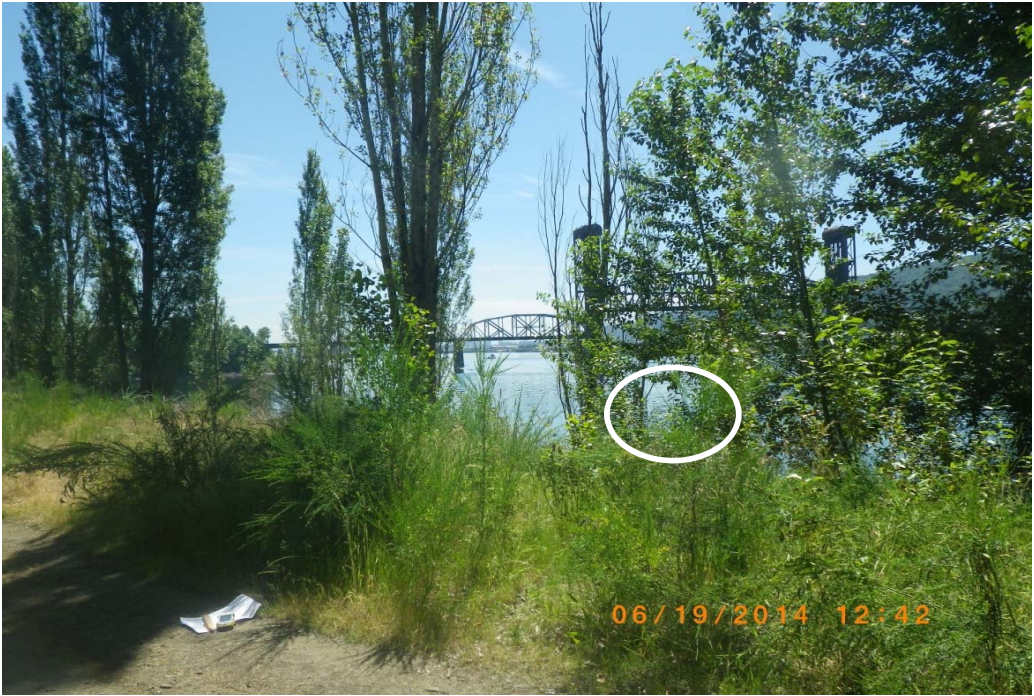
Photo Date: 6/19/2014	
Orientation: Southeast	
Description: Looking from path toward location DU-6-COMP-6-4. Approximate location over the top of the riverbank shown in the white oval.
